John E. Goode Pre-Trial Detention Facility Replacement

Executive Summary

POLICE MEMORIAL BUILDING REPLACEMENT

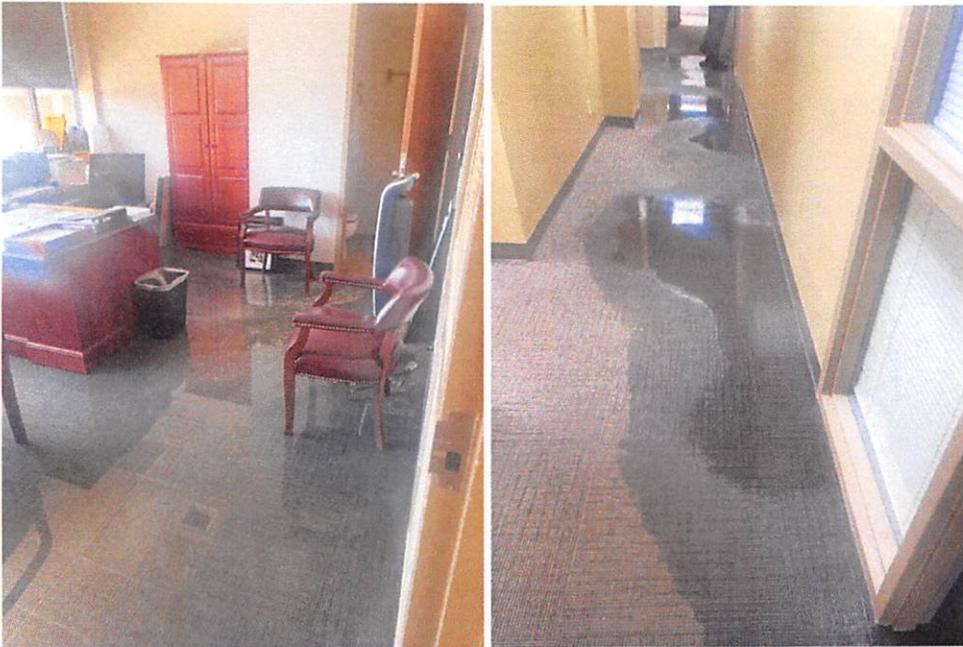
The plumbing system is in constant need of repair. There are constant leaks and sewage backups throughout the facility, causing damage to the facility and equipment. In the last month, the administrative offices have been severely flooded twice resulting in thousands of dollars in damages. The below pictures are from a flood 3 weeks ago. It happened again this past weekend. It should be noted that this is not clean water.
